CODG(21)01

MSC ZOE CONTAINER LOSS INCIDENT: CONCLUSIONS FROM THE INVESTIGATION REPORT

Loss of containers overboard from MSC ZOE

1-2 January 2019

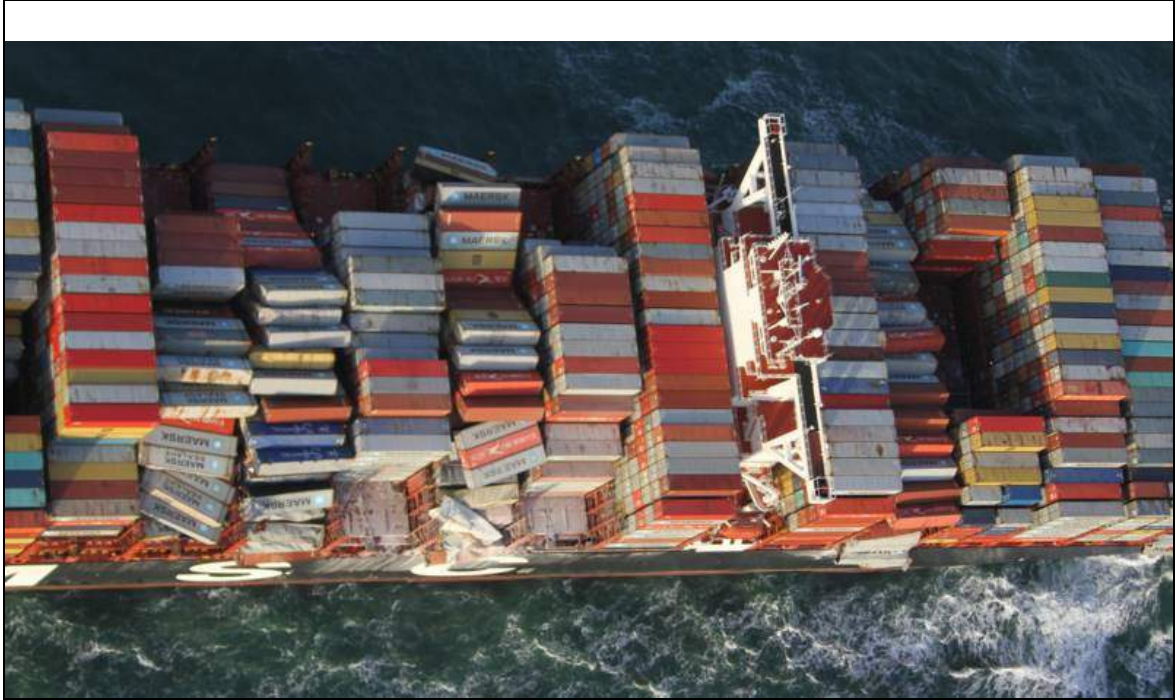
Figure 3: Top view MSC ZOE following the loss overboard of the containers. (Source: Netherlands Coastguard)

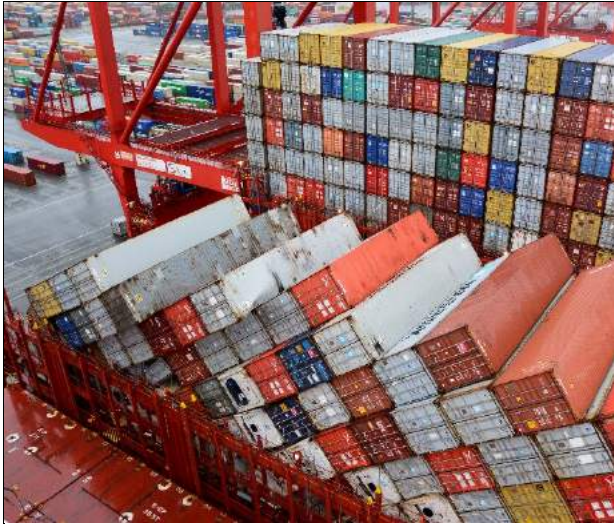
Figure 7: View on bay 26 (Source: DSB)

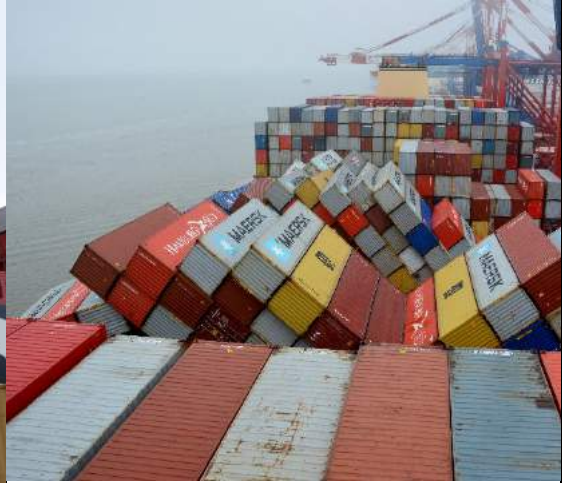
Figure 10: View on bay 42, 50 and 54 (Source: DSB)

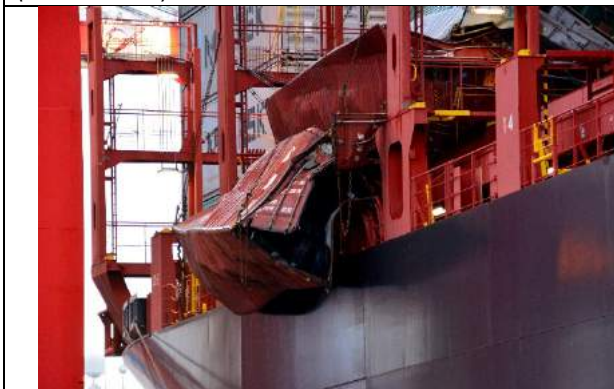
Figure 11: View on bay 10, port side. (Source: DSB)

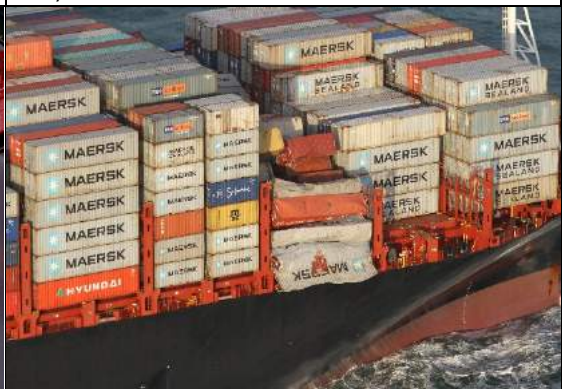
Figure 12: View on bay 10, starboard side. (Source: Netherlands Coastguard)

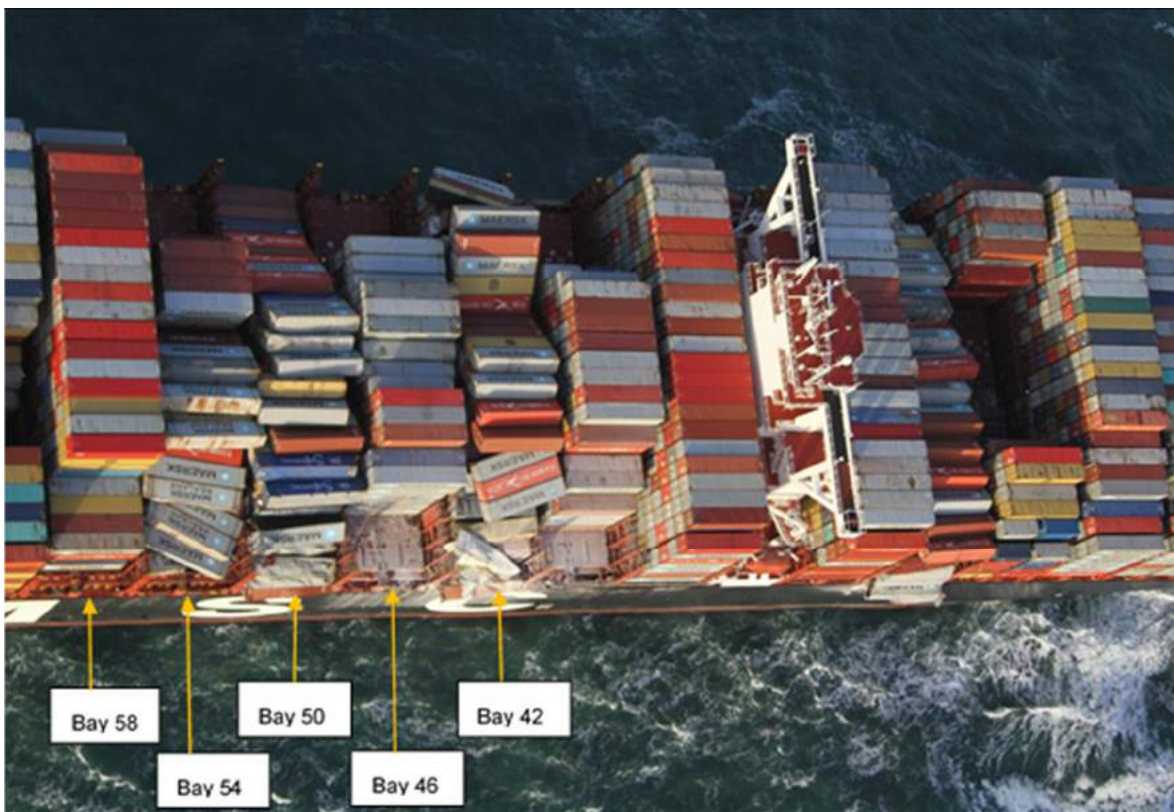
Figure 25: Top view of the bays with lost containers. (Source: The Netherlands Coast guard)

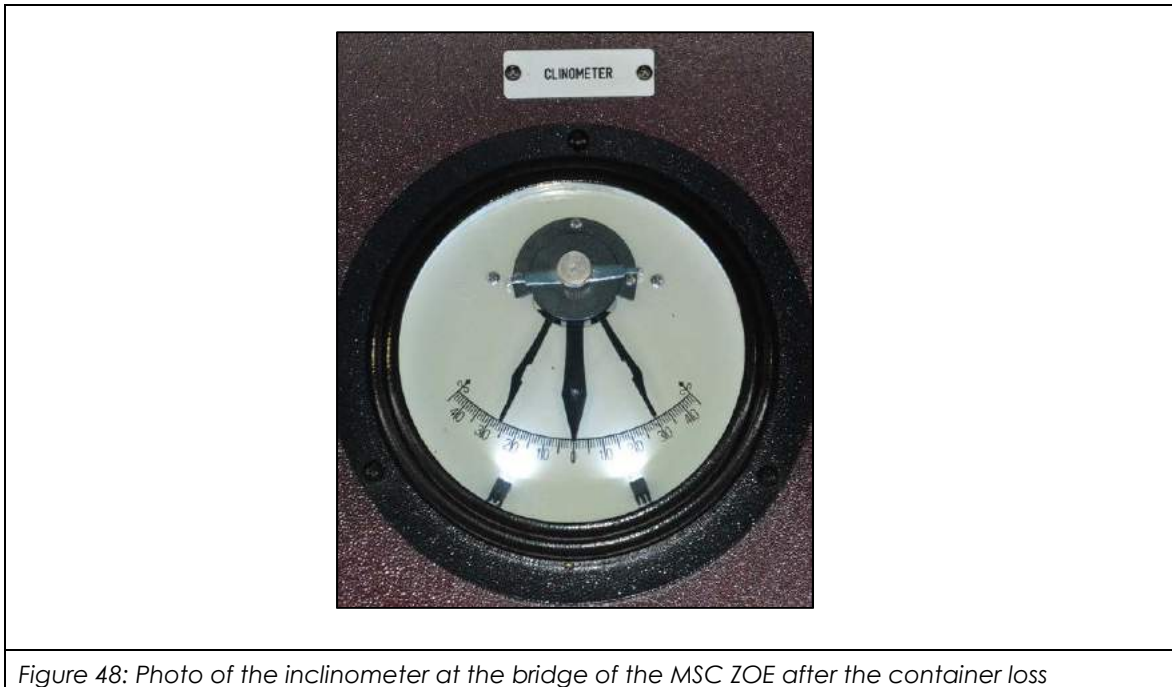
Figure 48: Photo of the inclinometer at the bridge of the MSC ZOE after the container loss
