CODG(21)01

MSC ZOE CONTAINER LOSS INCIDENT: CONCLUSIONS FROM THE INVESTIGATION REPORT

Loss of containers overboard from MSC ZOE

1-2 January 2019

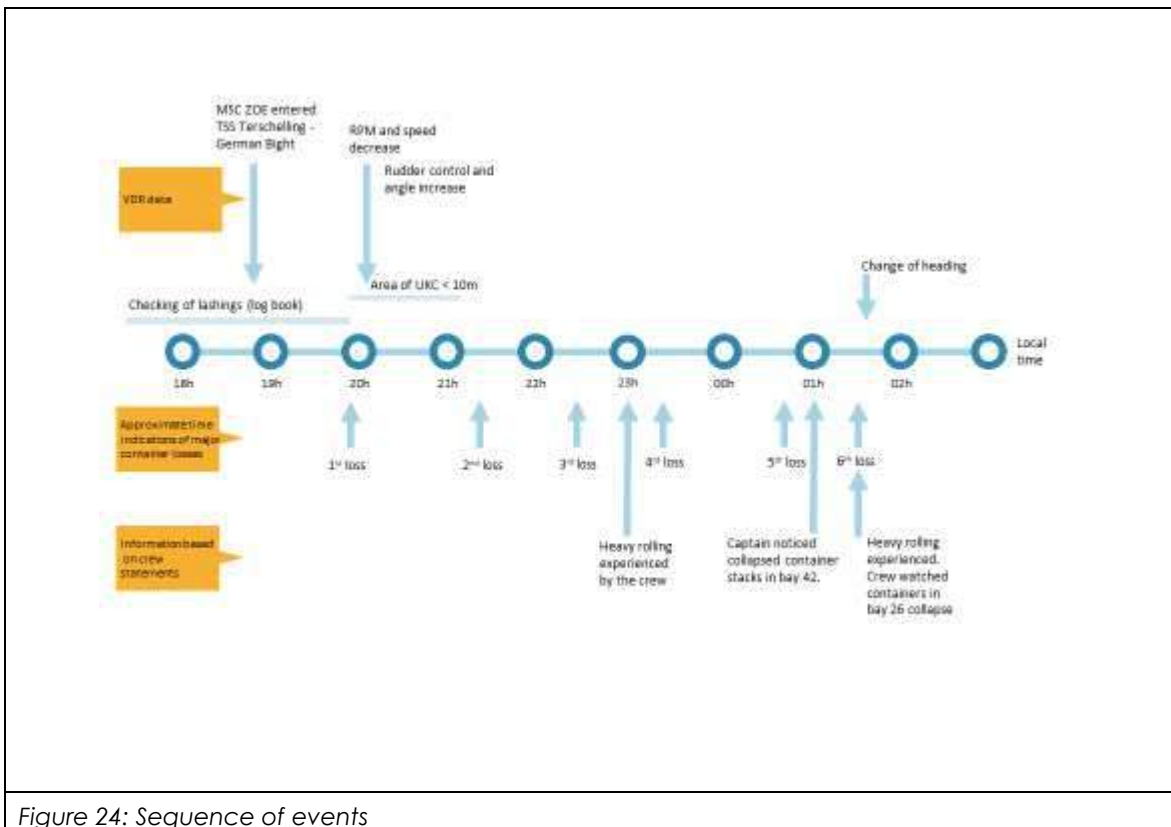
Figure 24: Sequence of events

Figure 24 summarizes the sequence of events and combines the data from the VDR, the information based on crew statements regarding the perceived ship motions and the major container loss moments based on the container recovery data.

According to crew statements, the MSC ZOE experienced in the TSS Terschelling – German Bight continuous rolling movements of 5 and 10° with occasional moments of heavier rolling of 15° up till 30° peaks. The VDR data confirms that when the MSC ZOE entered the TSS Terschelling – German Bight the ship started to roll continuously.

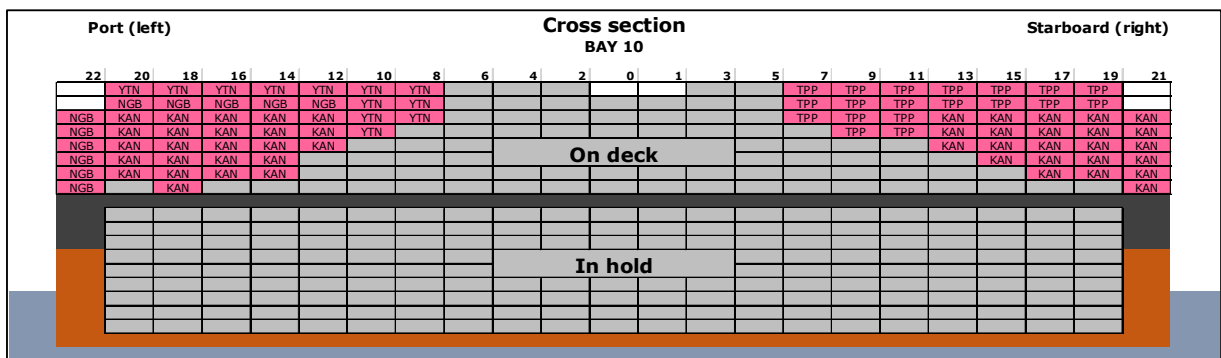
In the following bay plans, the lost containers are coloured per bay, based on where the containers, or parts of the containers were found. The MSC ZOE lost containers from the bays 10 (9/11) (pink), 26 (green), 42 (orange), 50 (red) and 58 (blue). The containers that remained on board in the respective bays are coloured grey²³.

The containers lost from bay 10²⁴ were loaded in all Asian ports except Xinyang and Shanghai and were destined for Gdansk.

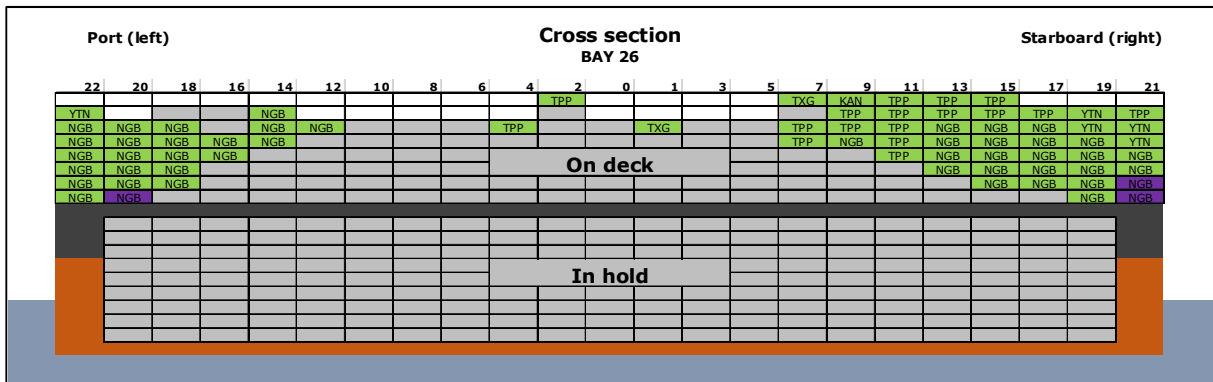
The containers lost from bay 26 were loaded in all Asian ports except Shanghai and destined for Gdansk. Bay 26 contained 3 containers with dangerous goods, coloured purple. The two containers on starboard were lost; the one on port side remained on board but lost some of its content.

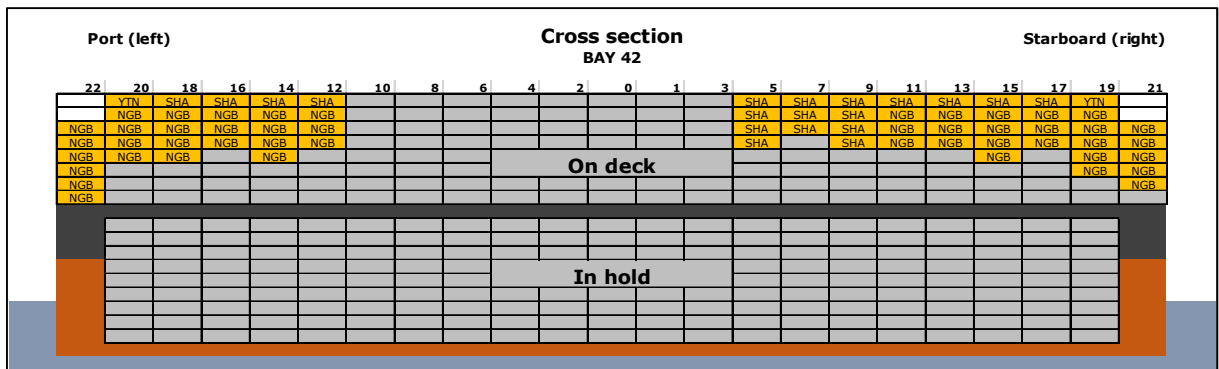
The containers lost from bay 42 were loaded in Ningbo, Shanghai and Yantian and were destined for Gdansk.

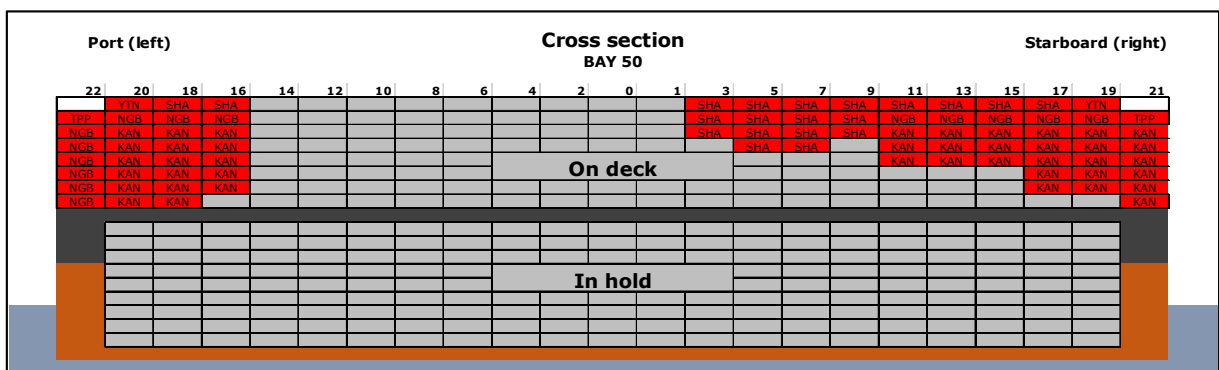
The containers lost from bay 50 were loaded in all Asian ports except Gwangyang and Shanghai and were destined for Gdansk.

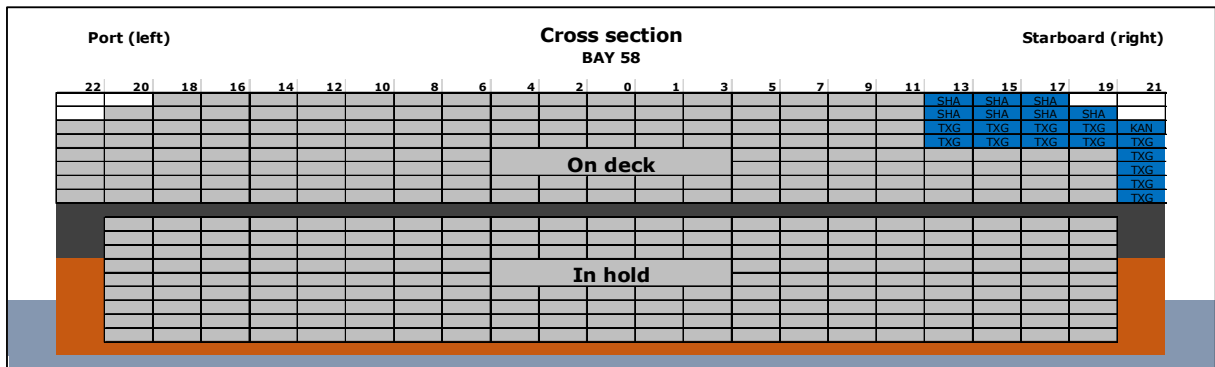
The containers lost from bay 58 were loaded in Xinyang, Gwanyang and Shanghai and destined for Gdansk.

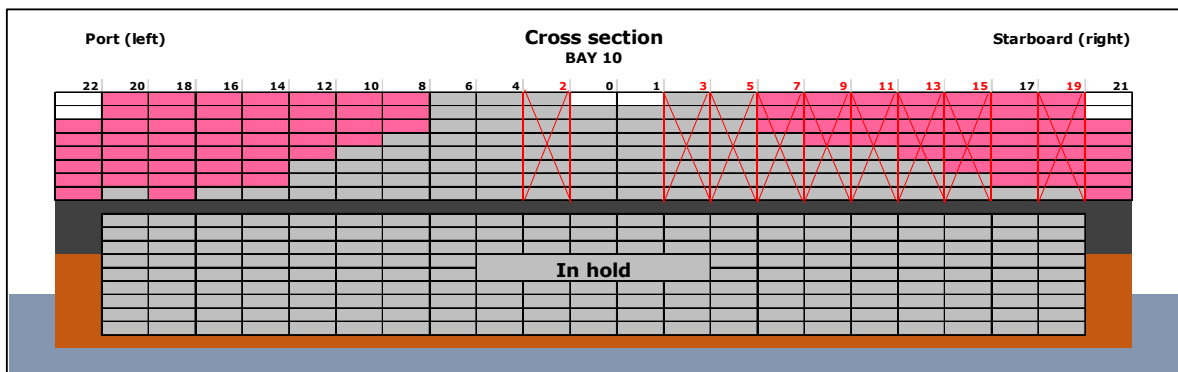
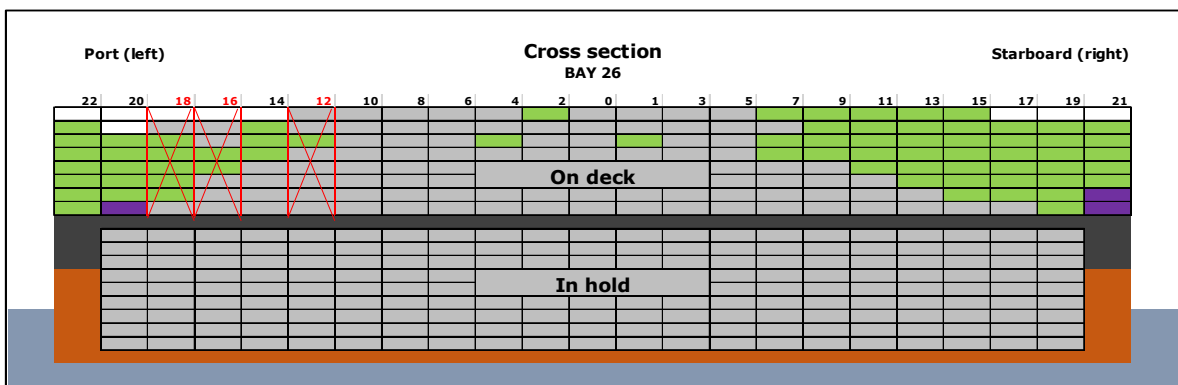
During the on-site investigation in Bremerhaven the loading computer on board the MSC ZOE indicated, for the accident voyage, red warning boxes in bays 10 (9/11), 18, 26, 30, 50, 62 and 70. A red warning box indicates an exceedance of any of the tolerance limit of one of the six possible reasons listed above. The exceedance of the tolerance limits where, however, not further specified. From bay 10 (9/11), 26 and 50, which showed red warning boxes based on the information retrieved in Bremerhaven, containers fell overboard. But bays 42 and 58, where containers also have been lost, did not have any red warning boxes.

Despite the preparation for the voyage from Sines to Bremerhaven, the loading computer on board the MSC ZOE indicated red warning boxes in bays 10 (9/11), 18, 26, 30, 50, 62 and 70. During the safety investigation, it was not possible to determine which limits had been exceeded. In the lashing software of the loading computer the applicable service area can be selected by a tick box (eg *Asia-Europe*). Depending on the area of operation, parameters used for the calculations may differ. MSC provided a simulation with the lashing software based on the loading condition of the accident voyage. The simulation showed a clear difference when ticking the box *Unrestricted service* or *Asia-Europe* in the service area menu. However, the displayed values as seen during the on-site investigation could not be reproduced afterwards, because it was not feasible to retrieve all used settings. MSC states that changing a few tick boxes in the computer may change all the calculations and this could have happened on board the MSC ZOE, since many people had been working on the computer, before the investigators were shown the data in Bremerhaven.

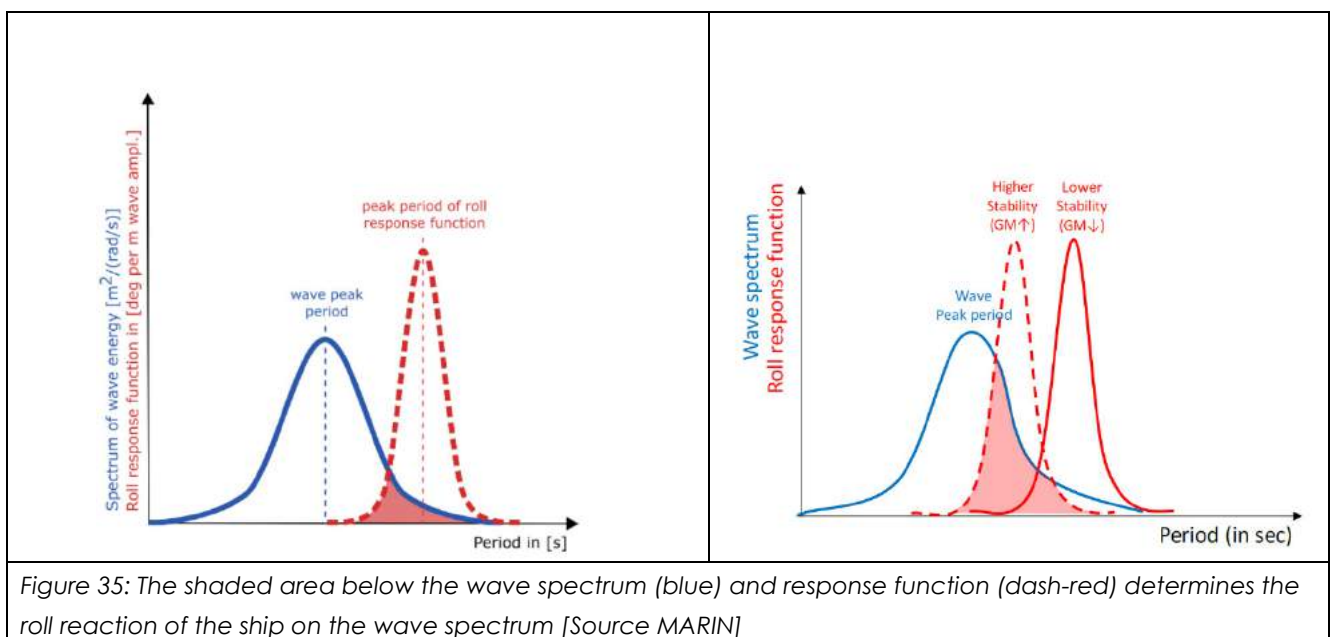
A ship's GM has an effect on this roll response function. MARIN states in its report (Appendix D) that present-day ULCSs show relatively high stability in roll because of their large beam and a fairly low position of the centre of gravity due to the stowage plans applied. As a result, these type of ships are more likely to show a higher roll response to wave periods present in the North Sea north of the Wadden Islands.

Figure 35: The shaded area below the wave spectrum (blue) and response function (dash-red) determines the roll reaction of the ship on the wave spectrum [Source MARIN]

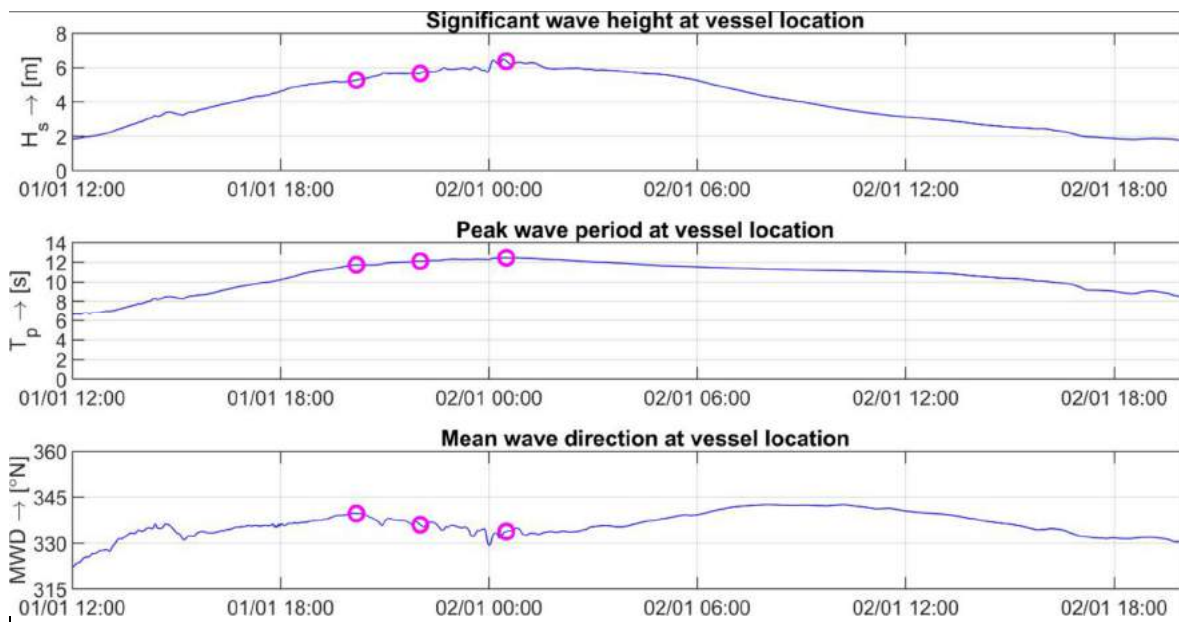
Deltares modelled the wave conditions encountered by the MSC ZOE when it was sailing in the TSS Terschelling – German Bight based on, among other sources, information of three wave buoy and five offshore platforms, see figure 40. The wave height that the MSC ZOE encountered developed with the increasing wind speed. On January 1 at around 15.00 hours LT, at the time that the ship was sailing along the Dutch west coast, the significant wave height (H_s) was 2.5 meters. Five hours later, at 20.00 hours, the significant wave height (H_s) was around 5.2 meters. The ship experienced the largest waves with a significant wave height of 6.5 meters at approximately 01.00 hours on January 2, after passing the island of Schiermonnikoog. The peak wave period (T_p) experienced during the moments of container loss (between 20:00 hours and 01:30 hours LT) were between 11.8 and 12.5 seconds.

Figure 40: Wave conditions along the route of the MSC ZOE.

The waves approached the MSC ZOE from abeam. This wind direction allows the waves to build up as there is a long fetch length available on the North Sea. Significant wave height increased from 5 m to 6.5 m at the peak of the storm. The maximum wave height during this time reached up to around 11 meters. The peak wave period encountered was approximately 11.8 - 12.5 seconds. The wave conditions are neither very extreme nor exceptional for this part of the North Sea.

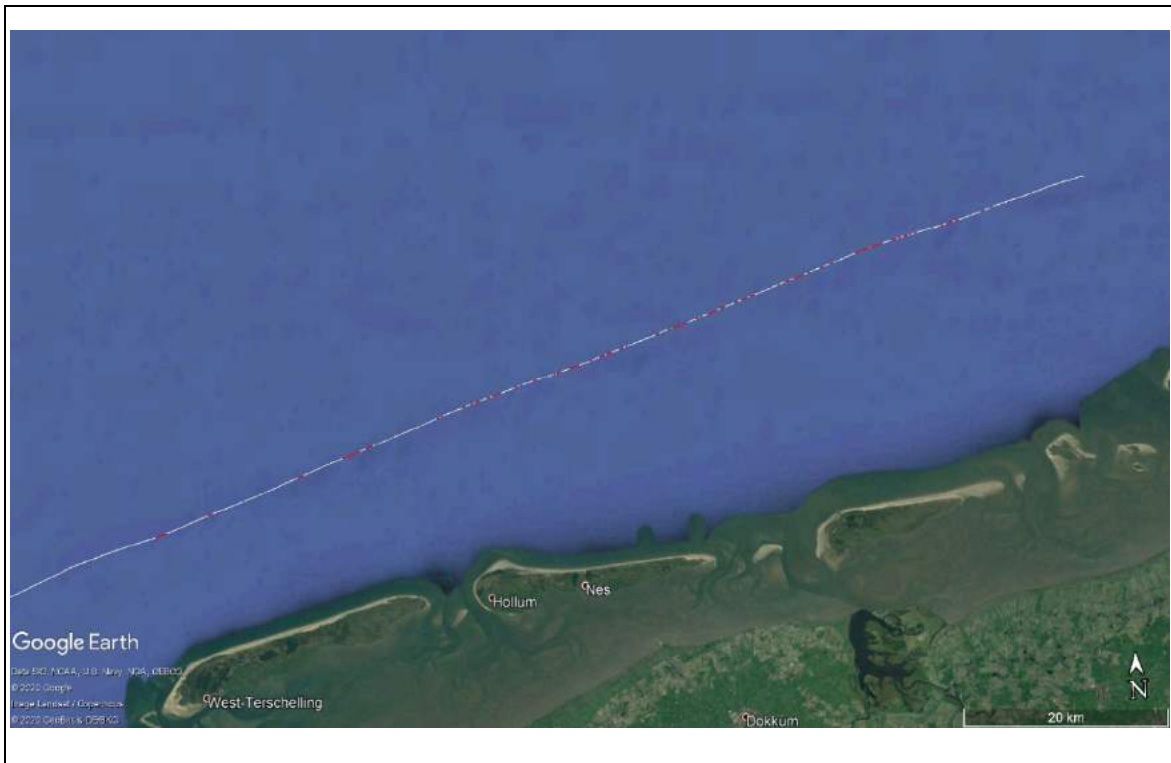
The mean, median and mode all indicate that a full roll period of the ship was approximately 14.7 seconds. Furthermore, based on the audio analysis, figure 43 was created. More intense rolling periods, where the peaks are audible to the human ear, are indicated in red.

Figure 43: Periods where the rolling motion was intense enough to be detectable by the human ear through shifting objects on the bridge are indicated in red. (Source: Google Earth)

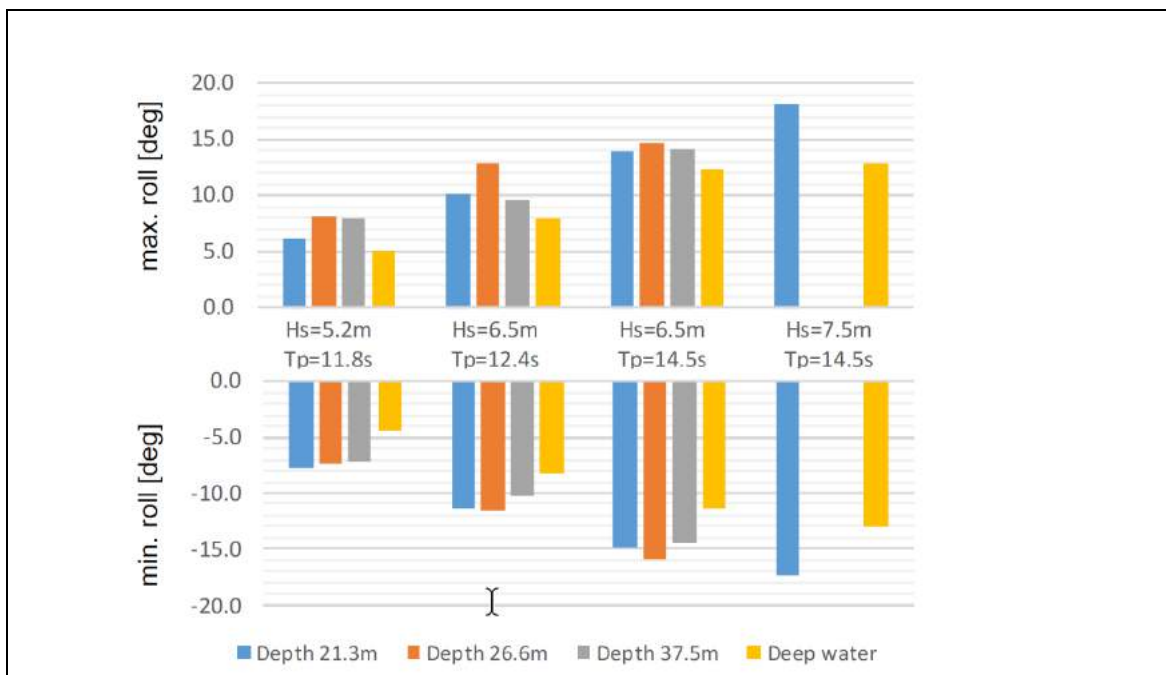
Similar results for UCLS in general were obtained from the basin tests performed by MARIN. The basin tests were conducted with variations in the significant wave height H_s and wave period T_p . The measured extreme roll amplitudes increase with an increase in H_s and T_p , see figure 46. For a significant wave height of 6.5m and a water depth of 26.6m, the largest roll amplitude measured was around 16°.

Figure 46: Extreme amplitudes of roll $V_s = 0$ kn, short-crested waves (Source MARIN)

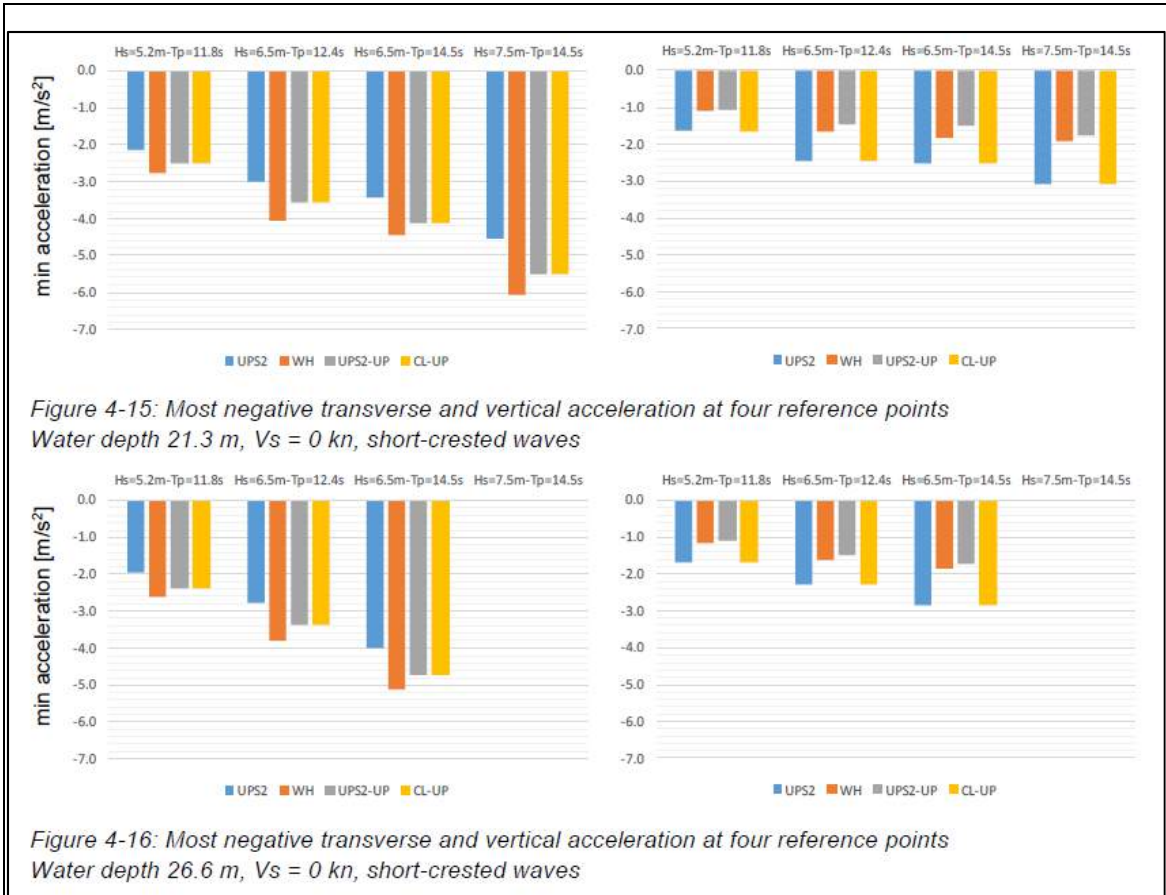
Considering the water depth the MSC ZOE encountered, the MARIN results for water depths of 21.3m and 26.6m are depicted below. The highest transverse accelerations in wave heights up to 6.5 m (Tp=14.5 s, water depth 26.6 m) reached 4.0 m/s² at the lowest

tier of containers on deck, 4.8 m/s² at the top of tier 7 and exceeded 5 m/s² at the wheelhouse, see figure 50. Overall it can be stated that the transversal accelerations increase with the height on deck due to the effect of roll. Accelerations are also found to be larger at a water depth of 26.6m, following the trend of roll (higher maximum roll angle in water depth of 26.6 m compared to 21.3 m).

Figure 50: Most negative transverse and vertical accelerations at four reference points. (Source: MARIN)

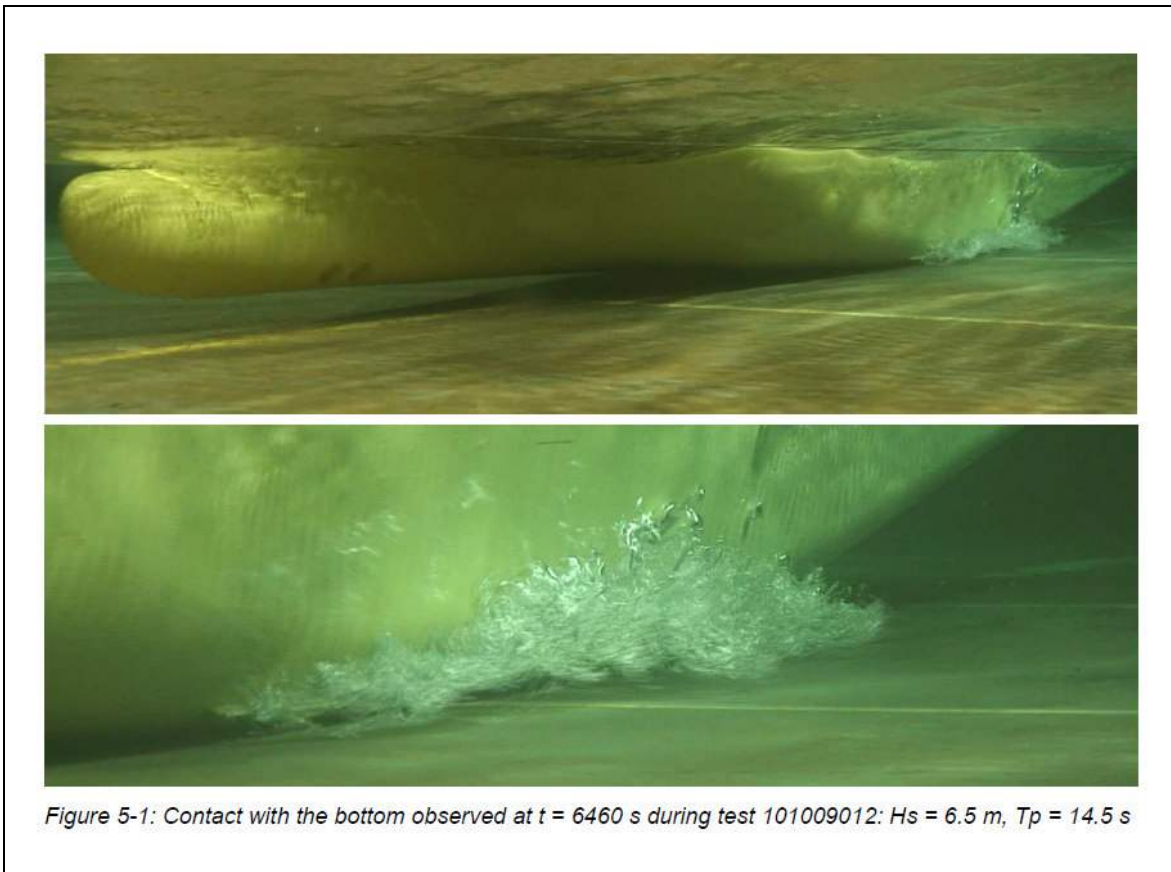
During the tests in the basin, contact or near contact of the model ship with the floor of basin was observed (see figure 51). The frequency of this varied with the wave and ship conditions. During the tests with short-crested waves contact with the basin floor was observed at a water depth of 21.3 m and a wave height of 6.5 meters and above and a peak period of 14.5 meters. The analysis by MARIN of the ship's motions shows that the model can touch the basin bottom when a large vertical heave motion is combined with a large roll motion at the same time in the passage of a group of relatively high waves. The ship also makes a transverse sway motion at that time.

Figure 51: Underwater images of the model ship at the moment of bottom contact (water depth 21,3 meter, $H_s=6.5m$, $T_p=14.5s$, $V_s=0kn$). (Source: MARIN)
